SD4HW & SD4FHW DVR “Delay Time” Issue

**AFFECTED: SD4HW, SD4FHW
As well as their Reseller Designation versions**

**FIELD SERVICE MEMO #52
Issue Date
March 24, 2023**

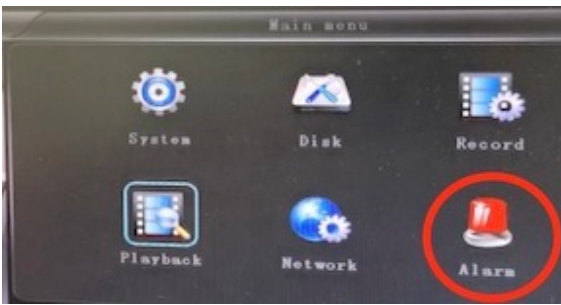
Topic	SD4HW & SD4FHW “Delay Time” function fails to keep DVR powered up after user set time threshold is met.
Problem	DVR default voltage is 24V so “low voltage” is defined as 20.0V DC.
Customer Complaint	Customers may notice their DVR is not recording post ignition, may shut down immediately when the vehicle is turned off or may constantly reboot seeking a appropriate power source.
Manufacturer Notice	On March 22nd, 2023 ABV was informed by a customer that the “Delay time” feature was not functioning properly. After getting the serial numbers from the customer we contacted the manufacture to let them know of the problems.
ABV Actions Taken	<p>ABV technician pulled several DVRs from inventory stock and tested them on the bench to verify the “Delay time” setting in them worked properly. They did not operate properly and the DVRs shut down immediately after the +12V power for Ignition was removed.</p> <p>We notified the manufacturer Product Development Team that we had replicated the customer reported problems with new units in inventory.</p> <p>The Development tTeam requested the “Sys Info” from the problematic DVRs and ABV tech provided Serial Numbers and screenshot of “SYS Info” screens to reflect the version firmware in the DVR. After product testing with proper firmware installed in test DVRs, the manufacturer Development team confirmed the same results.</p> <p>Approximately 24 hours later the Development Team requested we check the Alarm sub menu setting for “Low Voltage”. We reported a “20.00”, meaning the DVR default was set to stop working at +20v DC, which is a problem when working on a 12v DVC vehicle.</p> <p>This highlighted the problems cause and provided a immediate solution, offered below:</p> <p>Due to this change we wanted to create this Service Memo to let customers know of this difference, also printed on all new Quotes, should they not be made aware of this in some other way.</p>

The Solution is a simple change of the Shut Down voltage in the Alarm Menu.

In the DVR Menu, Select Alarm.
